Your Inspection Report

1234 Somewhere St
Saint John, NB E2L 2M9

INSPECTION DATE:
Friday, December 8, 2023

RE: Report No. 3531
1234 Somewhere St
Saint John, NB
E2L 2M9

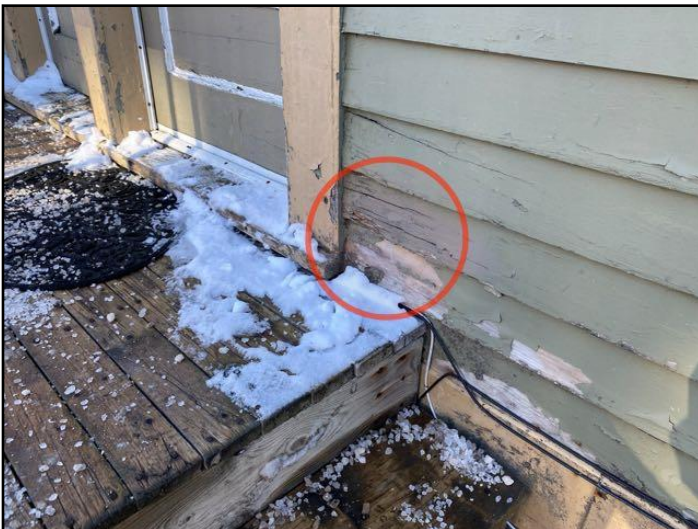
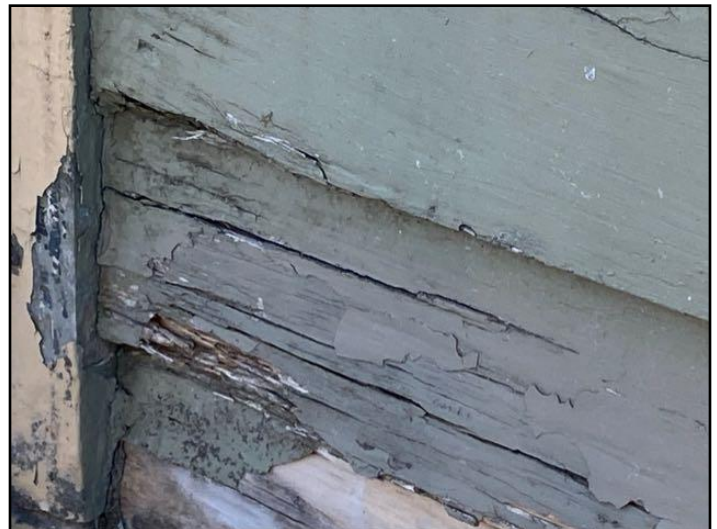
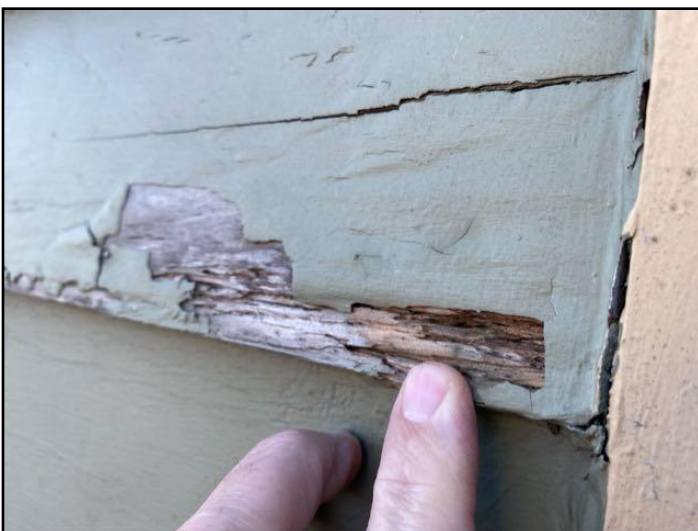
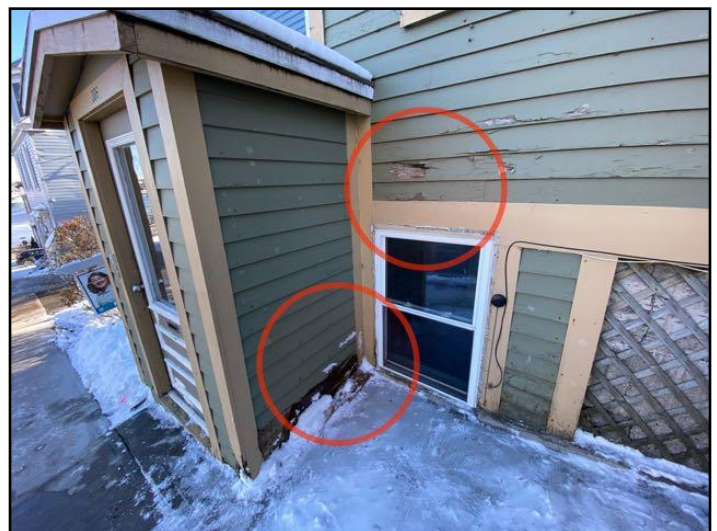
Condition: • [Cracked, split or broken](#)

Rot and damage noted

Implication(s): Chance of water damage to structure, finishes and contents

Task: Service General Repair

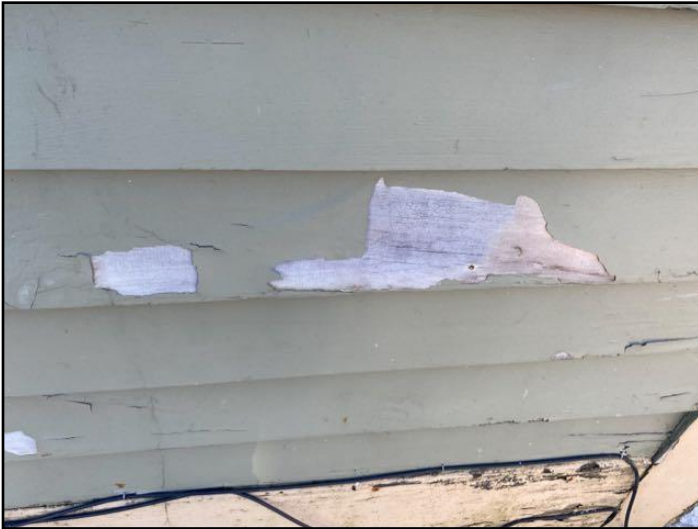
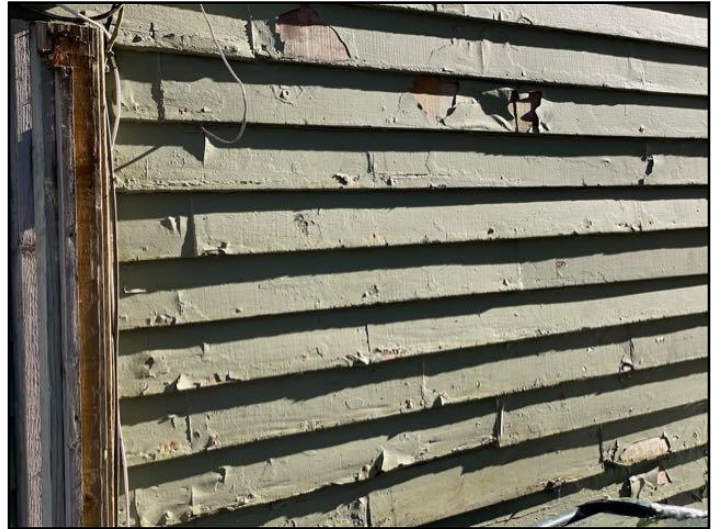
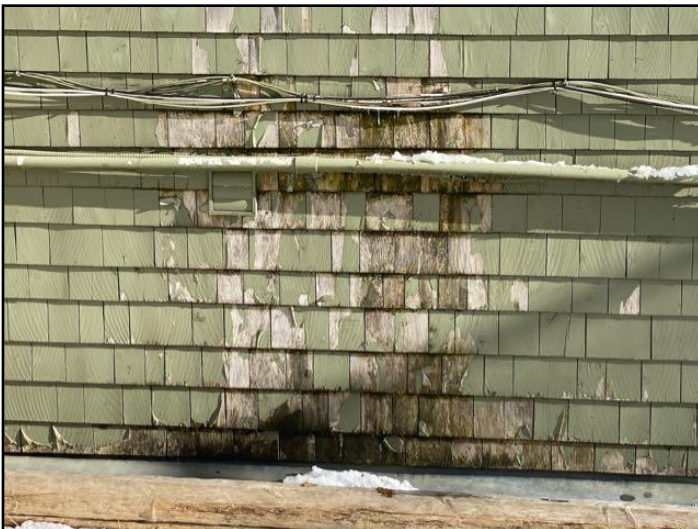
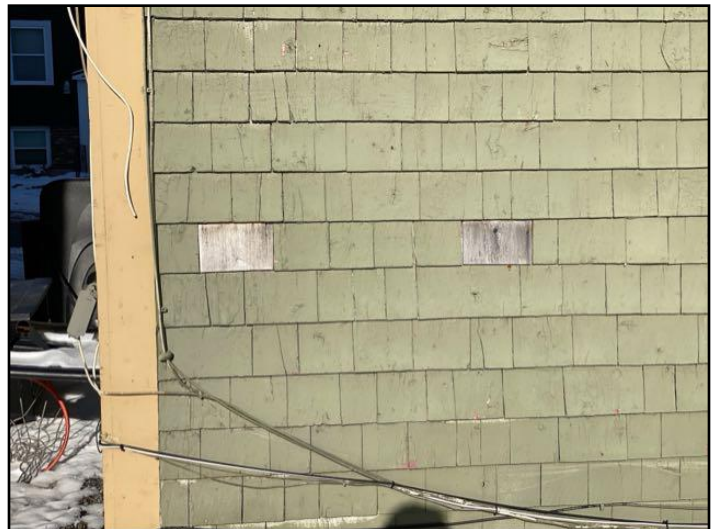
Condition: • [Paint or stain - needed](#)

Task: Service General Repair

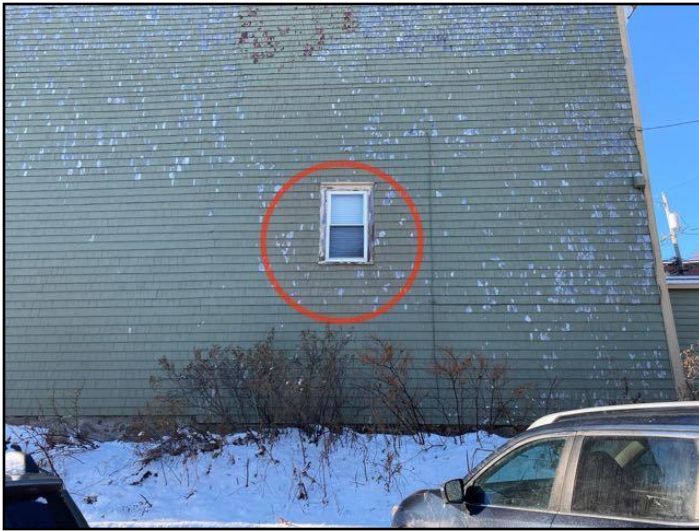
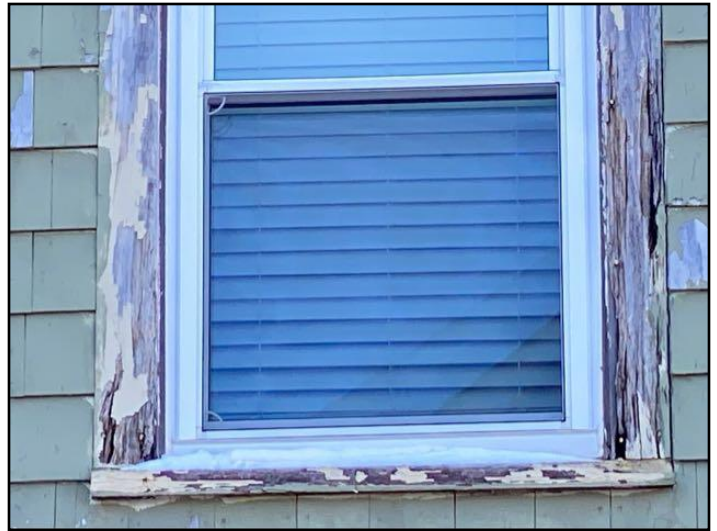
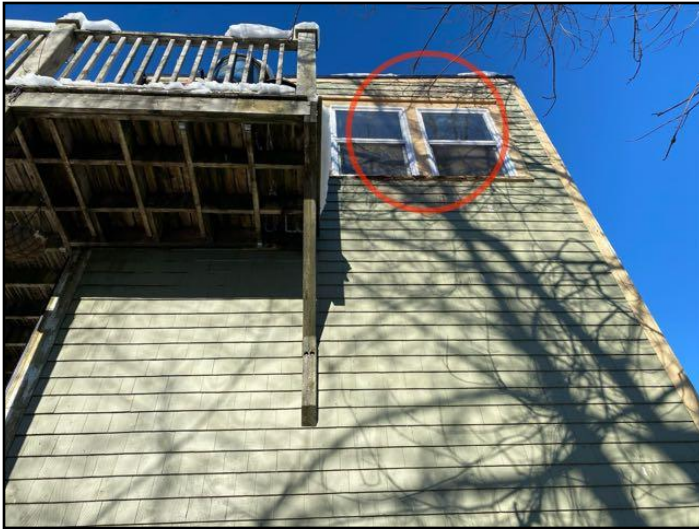
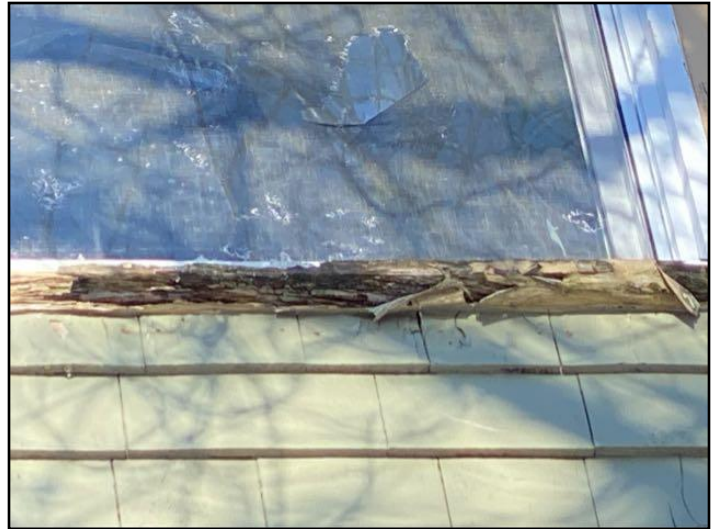
EXTERIOR GLASS/WINDOWS \ Frames

Condition: • Rot

Implication(s): Material deterioration

Task: Service General Repair

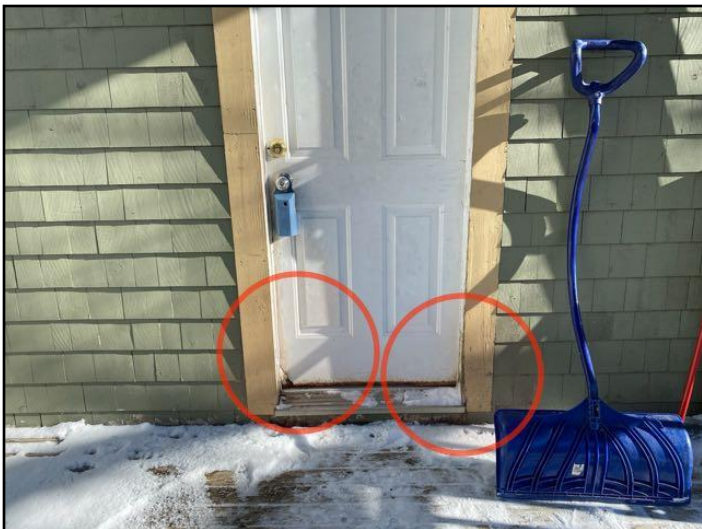
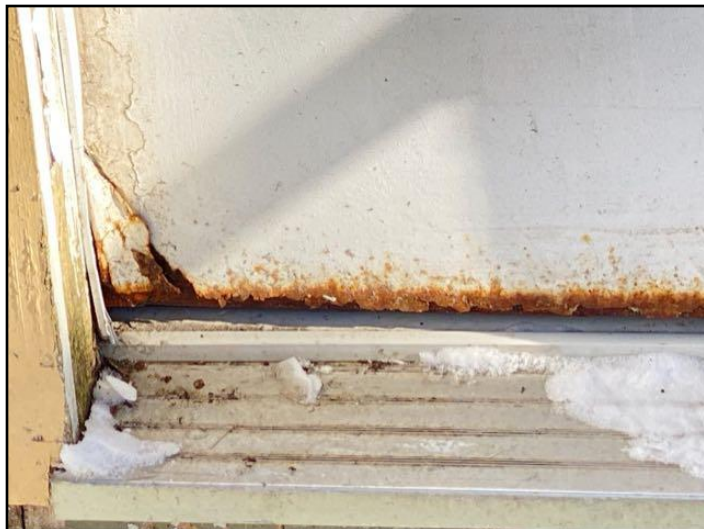
DOORS \ Doors and frames

Condition: • [Damage](#)

Implication(s): Poor security | Chance of damage to finishes and structure

Task: Repair or Replace

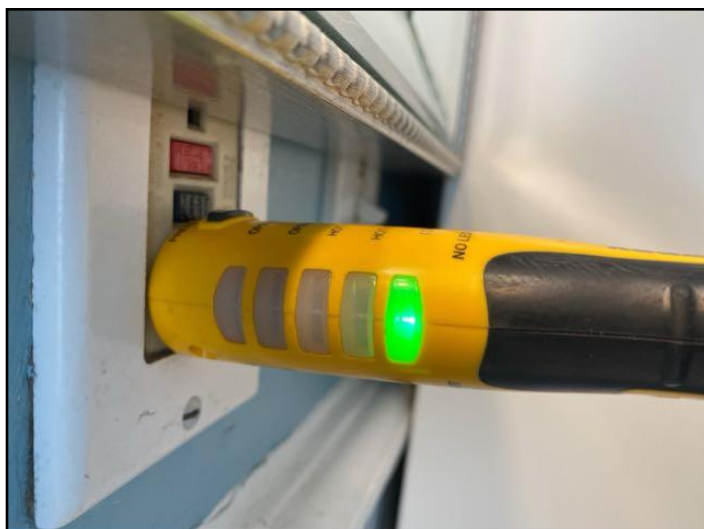
Condition: • The outlet at the bathroom was powered by the light switch. This configuration, although correct, can be an annoyance or inconvenience in today's life style with rechargeable appliance/devices. This configuration would require the light t remain on in order to charge, toothbrushes, razors, phones, etc.

Task: Recommend Upgrade to Current Standard

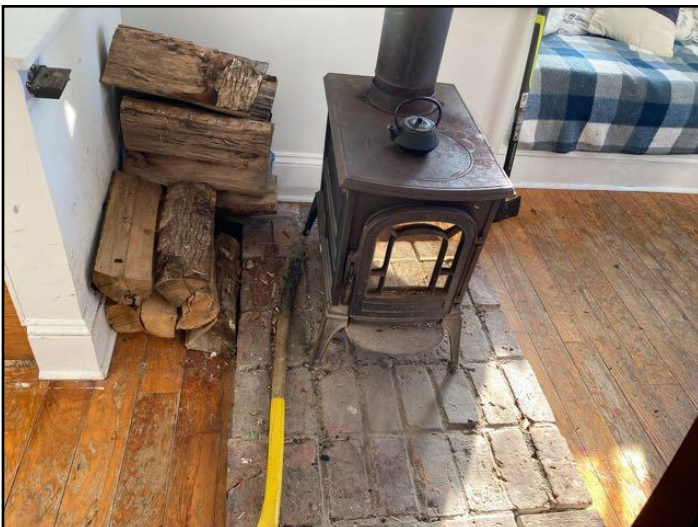
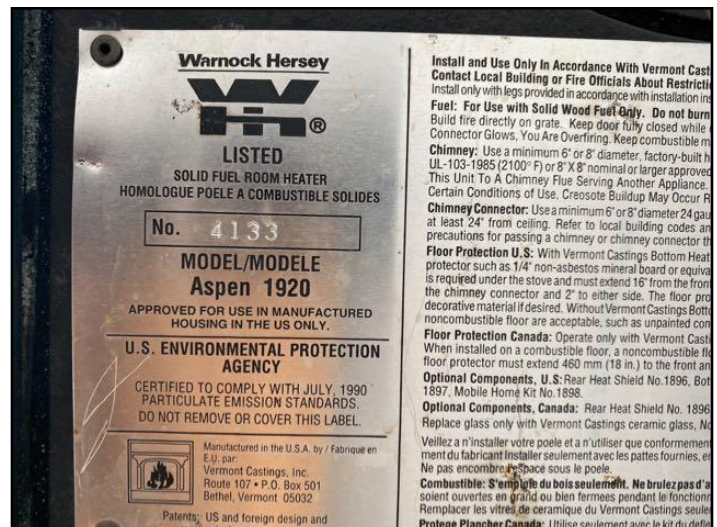
Condition: • [At the time of the inspection, a WETT inspection of the wood-burning system was not requested and](#) therefore not conducted. Inspection of wood-burning system typically includes a visual examination of the following: adequate hearth; firebox condition; operable damper; visible flue condition; spark barrier; and exterior condition. A full inspection of the wood-burning system lies beyond the scope of the Standard Home Inspection. For a complete inspection to more accurately determine the condition of the wood-burning system and to ensure that safe conditions exist, the inspector recommends that you have the wood-burning system further evaluated by a specialist, WETT specialist. Find a WETT-certified specialist near you at <http://www.wettinc.ca>

Implication(s): Fire safety | Fire Hazard | Insurance concern

Task: Further evaluation by a specialist

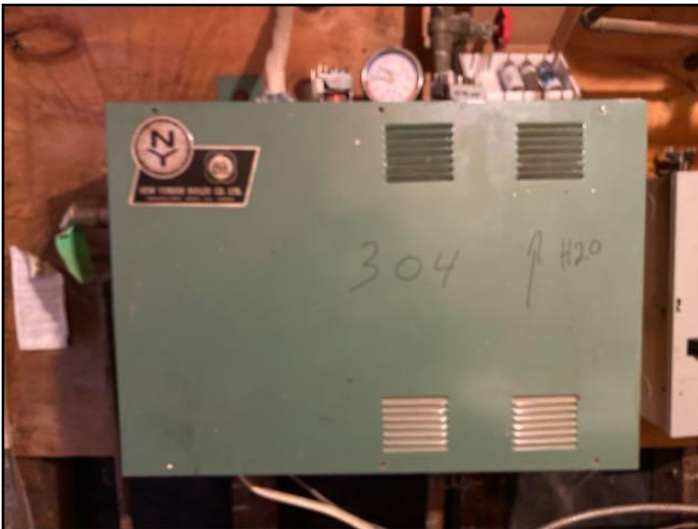
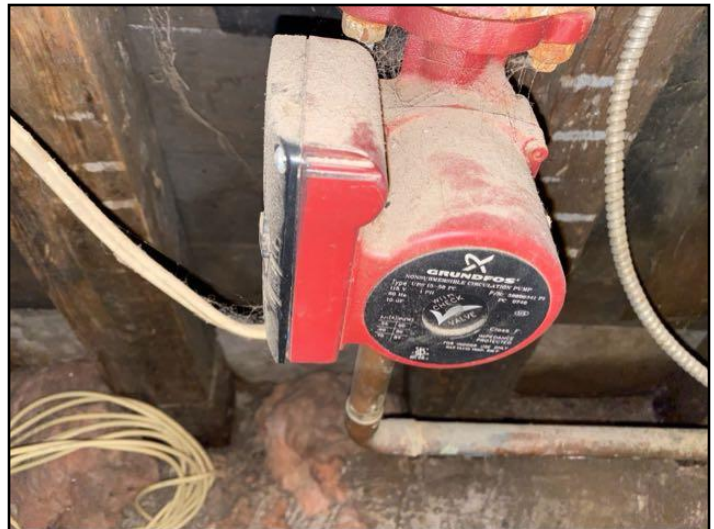
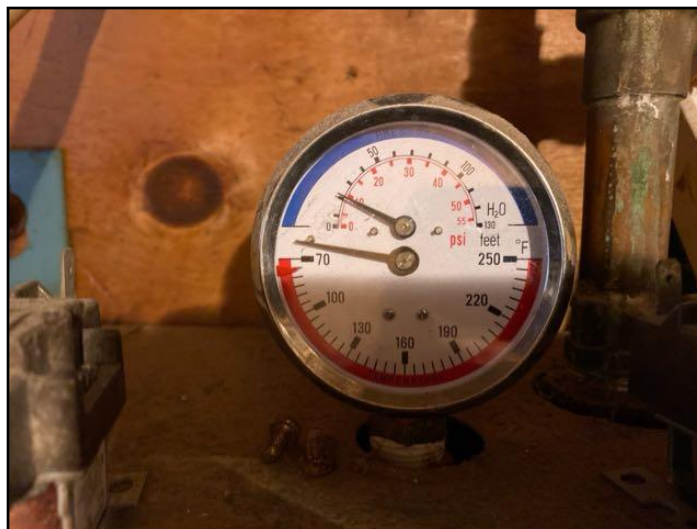
ELECTRIC BOILER \ Life expectancy

Condition: • Near or past life expectancy - Although the system is near or at the end of its life expectancy, continue to use and maintain the unit until it fails.

Task: Service by a Specialist

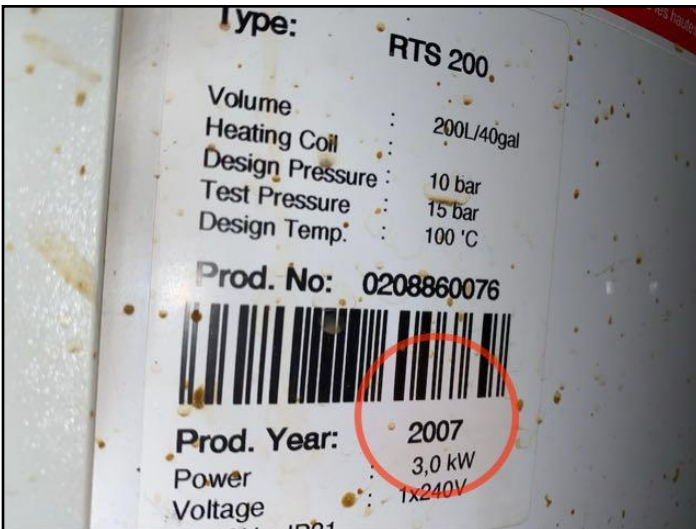
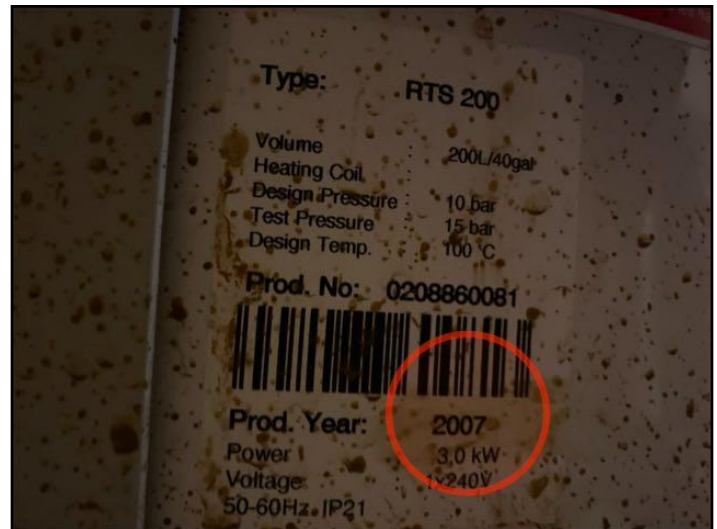
Condition: • The water heater, though functional during the inspection, is past the end of its "approximate" life expectancy (8 to 12 years based on a 2007 study done by the Nation Association of Home Builders) and may need replacement anytime.

Task: Replace

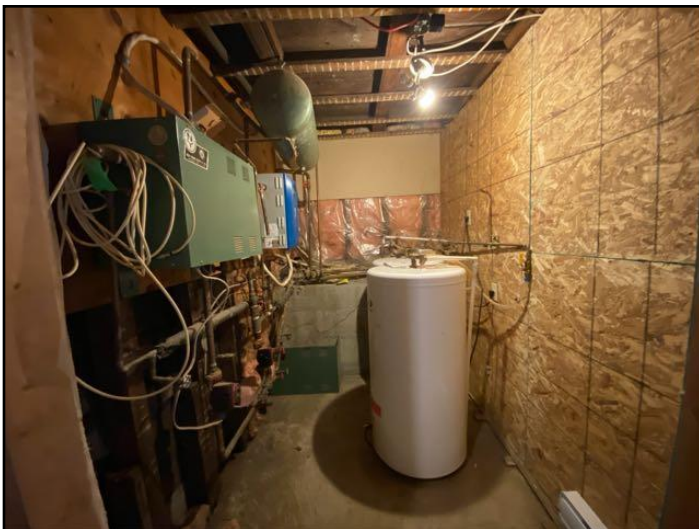
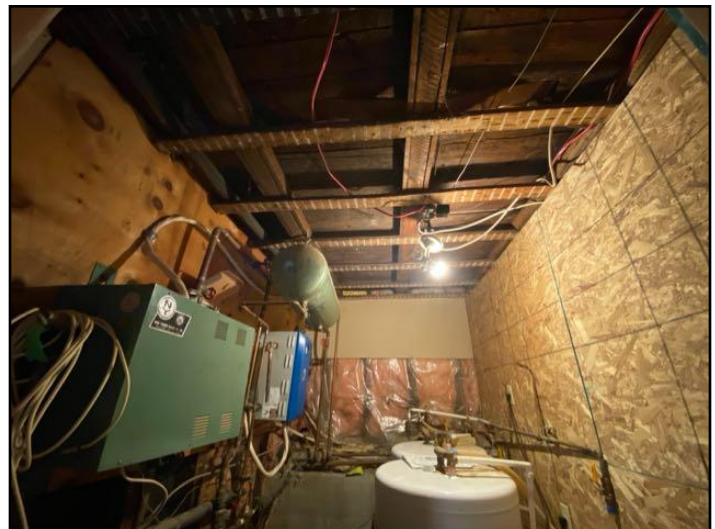
Condition: • Unfinished

Recommend finishing boiler room for added fire safety to current standards and best practices

Task: Finish

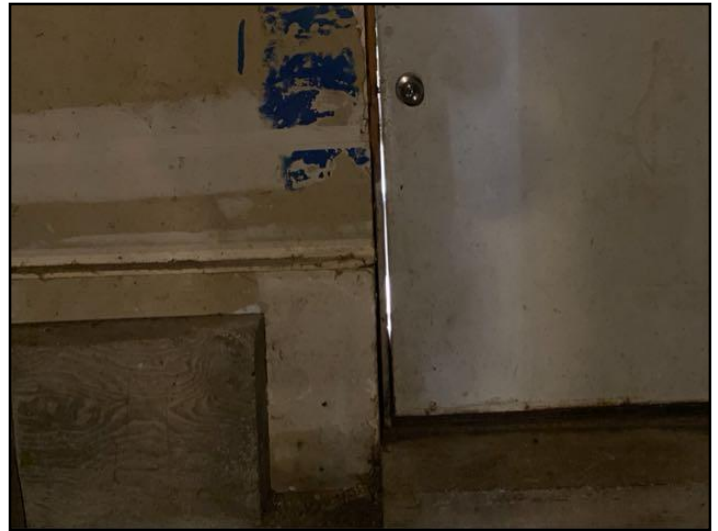
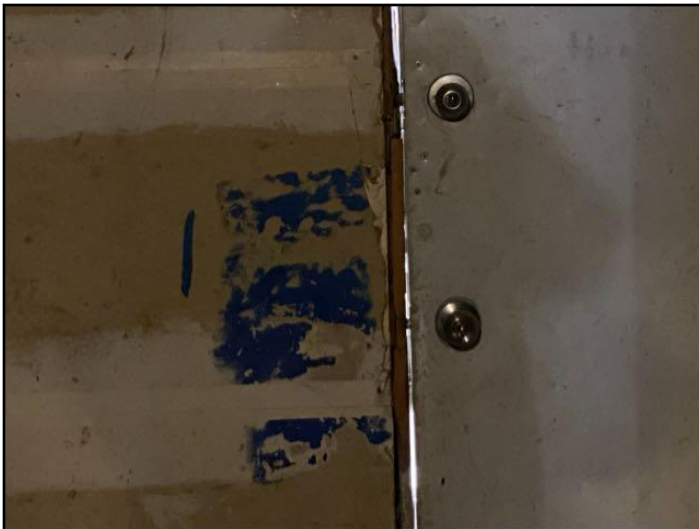
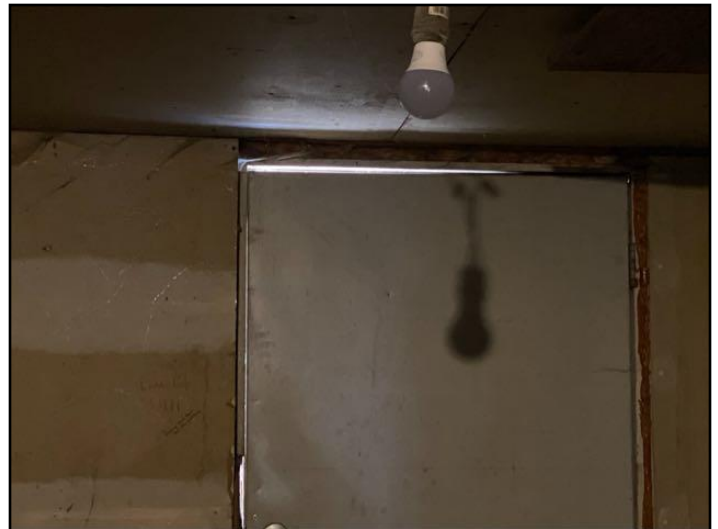
DOORS \ Doors and frames

Condition: • [Weatherstripping missing or ineffective](#)

Task: Service General Repair

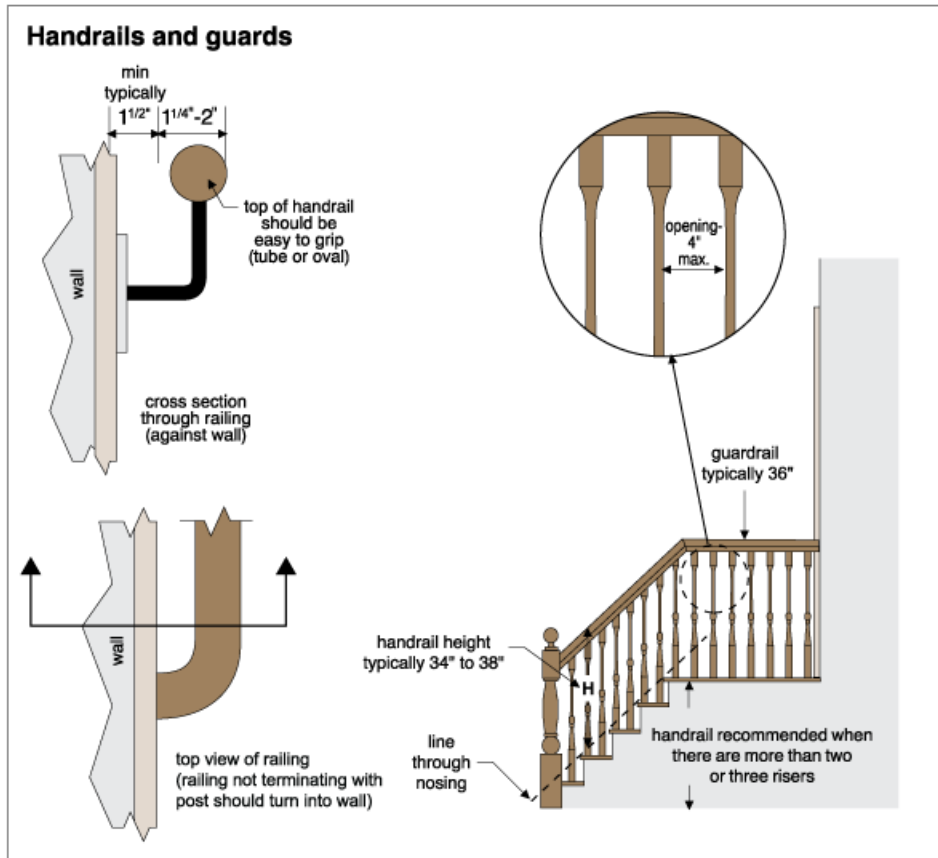
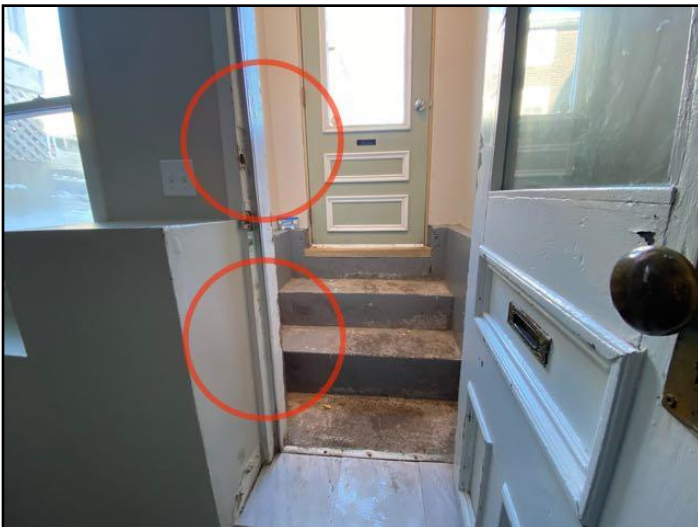
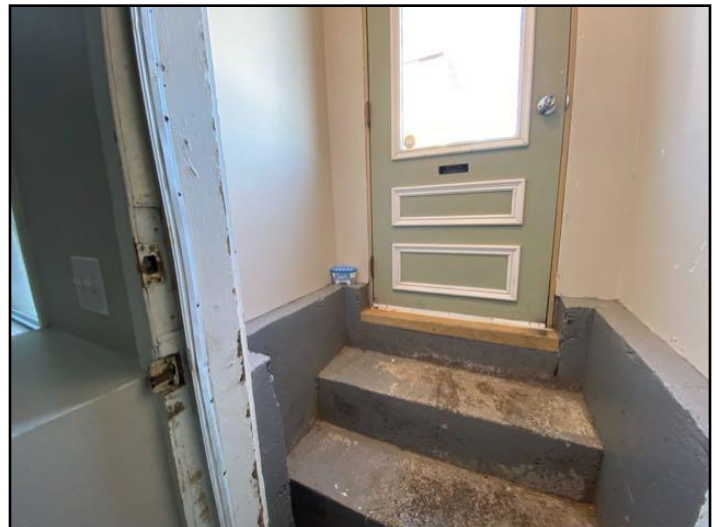
STAIRS \ Handrails and guards

Condition: • This staircase had no handrail installed. This condition is a potential fall hazard. In order to comply with generally accepted current standards which require a handrail at staircases with 4 or more risers, this staircase would need a handrail installed.

Implication(s): Fall hazard

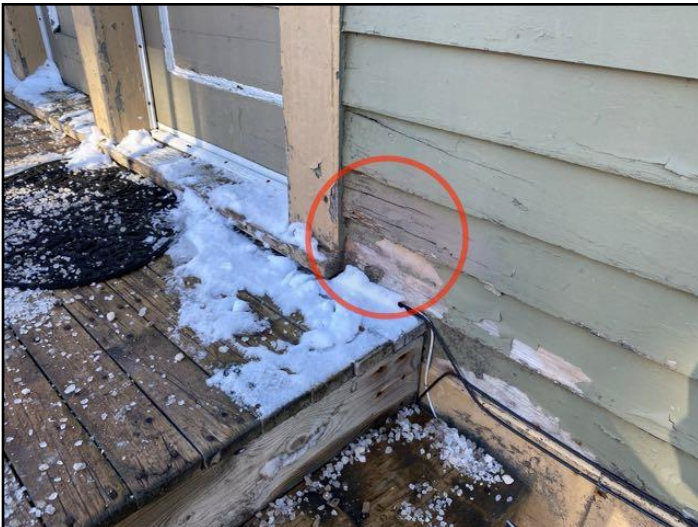
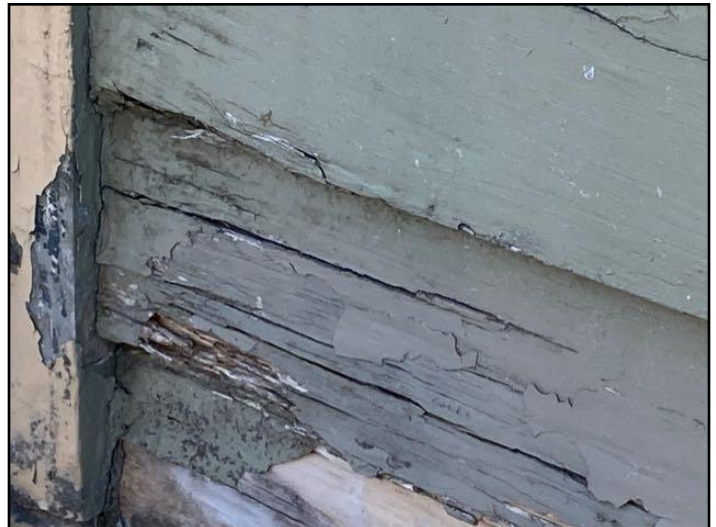
Condition: • [Cracked, split or broken](#)

Rot and damage noted

Implication(s): Chance of water damage to structure, finishes and contents

Task: Service General Repair

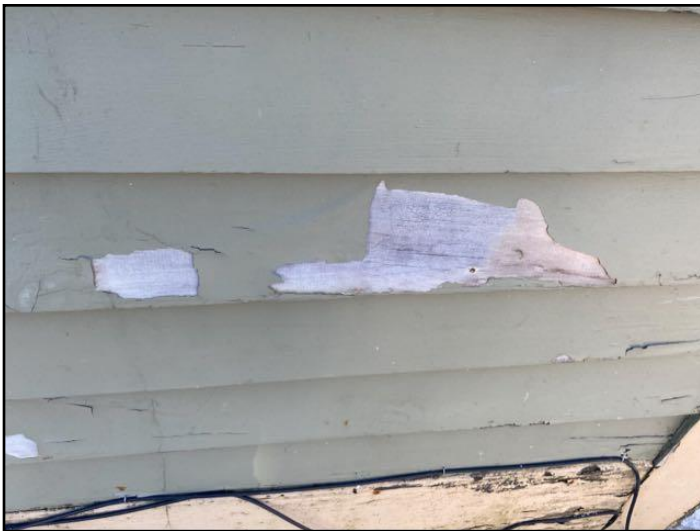
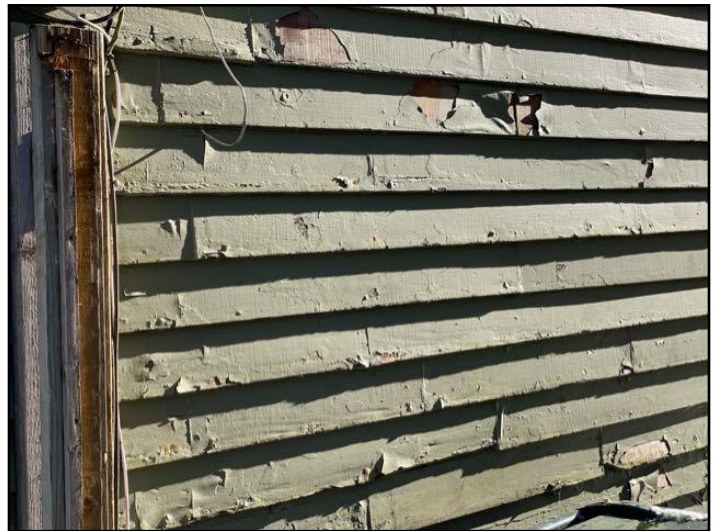
Condition: • [Paint or stain - needed](#)

Implication(s): Shortened life expectancy of material

Task: Service General Repair

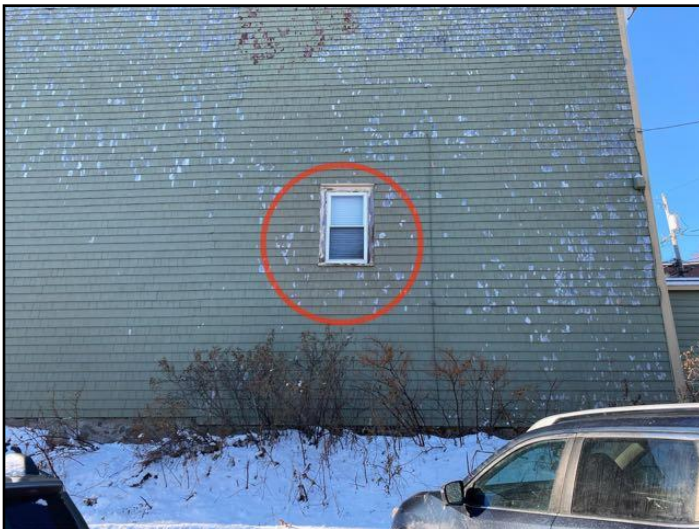
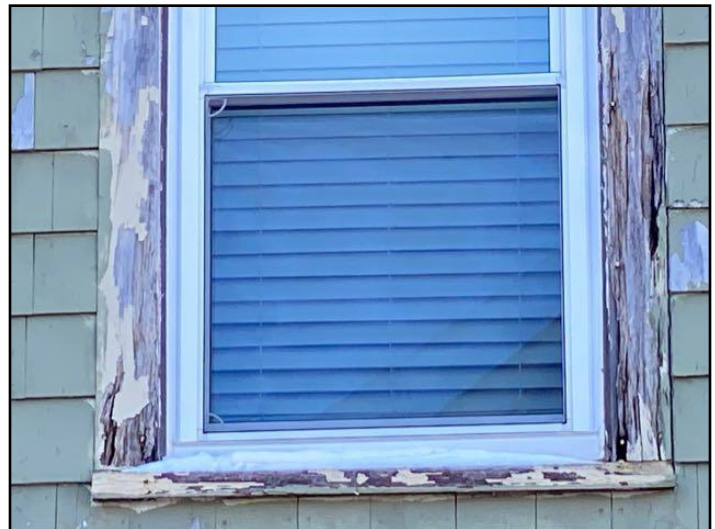
EXTERIOR GLASS/WINDOWS \ Frames

Condition: • Rot

Implication(s): Material deterioration

Task: Service General Repair

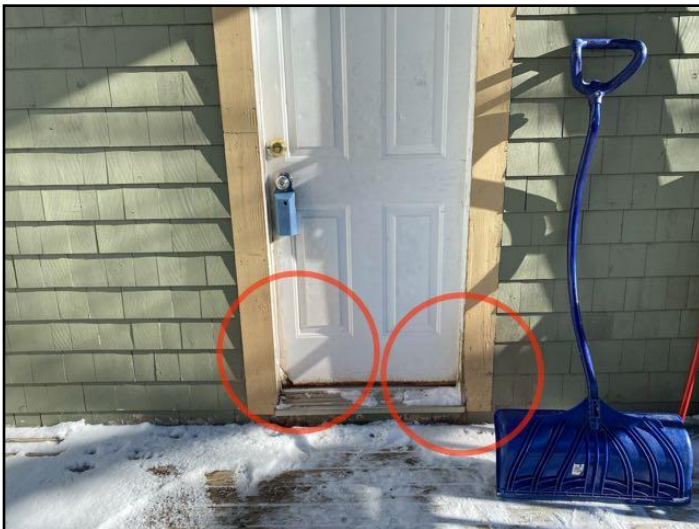
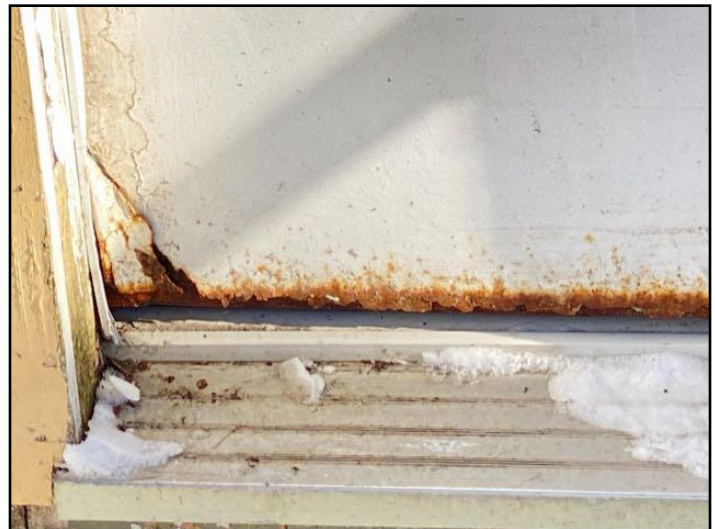
DOORS \ Doors and frames

Condition: • [Damage](#)

Implication(s): Poor security | Chance of damage to finishes and structure

Task: Repair or Replace

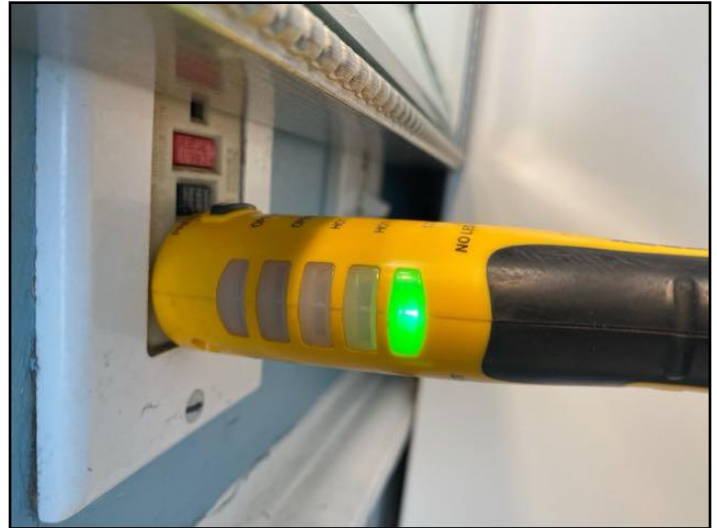
Condition: • The outlet at the bathroom was powered by the light switch. This configuration, although correct, can be an annoyance or inconvenience in today's life style with rechargeable appliance/devices. This configuration would require the light t remain on in order to charge, toothbrushes, razors, phones, etc.

Task: Recommend Upgrade to Current Standard

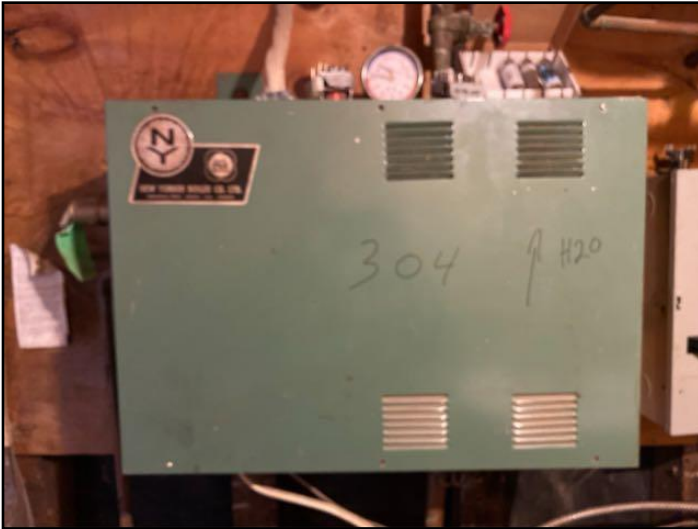
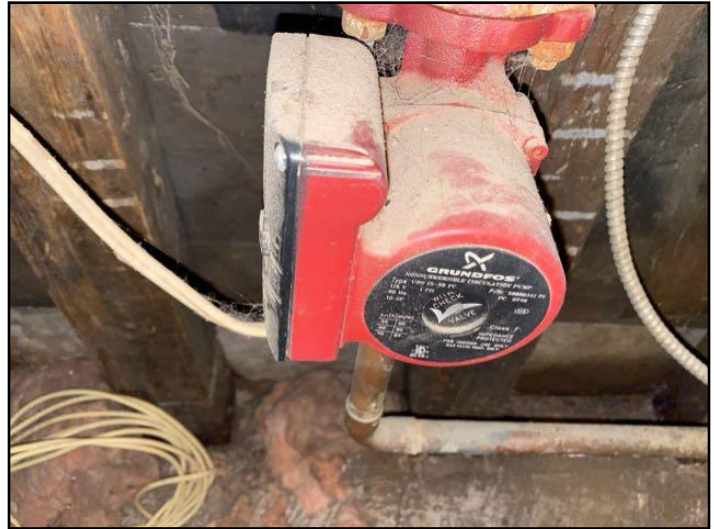
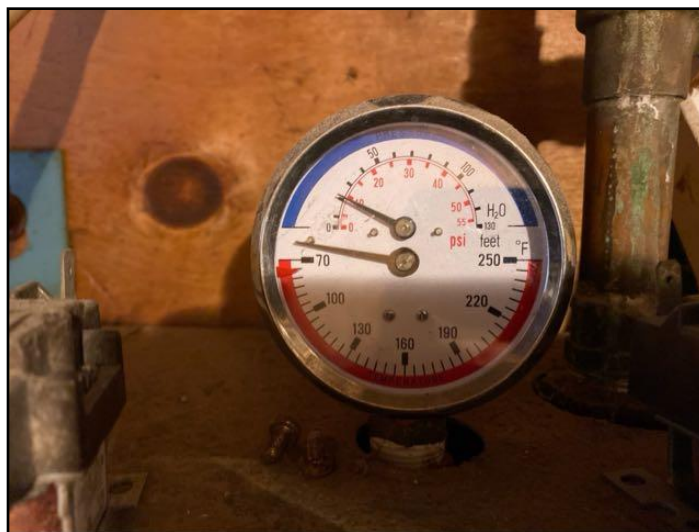
ELECTRIC BOILER \ Life expectancy

Condition: • Near or past life expectancy - Although the system is near or at the end of its life expectancy, continue to use and maintain the unit until it fails.

Task: Service by a Specialist

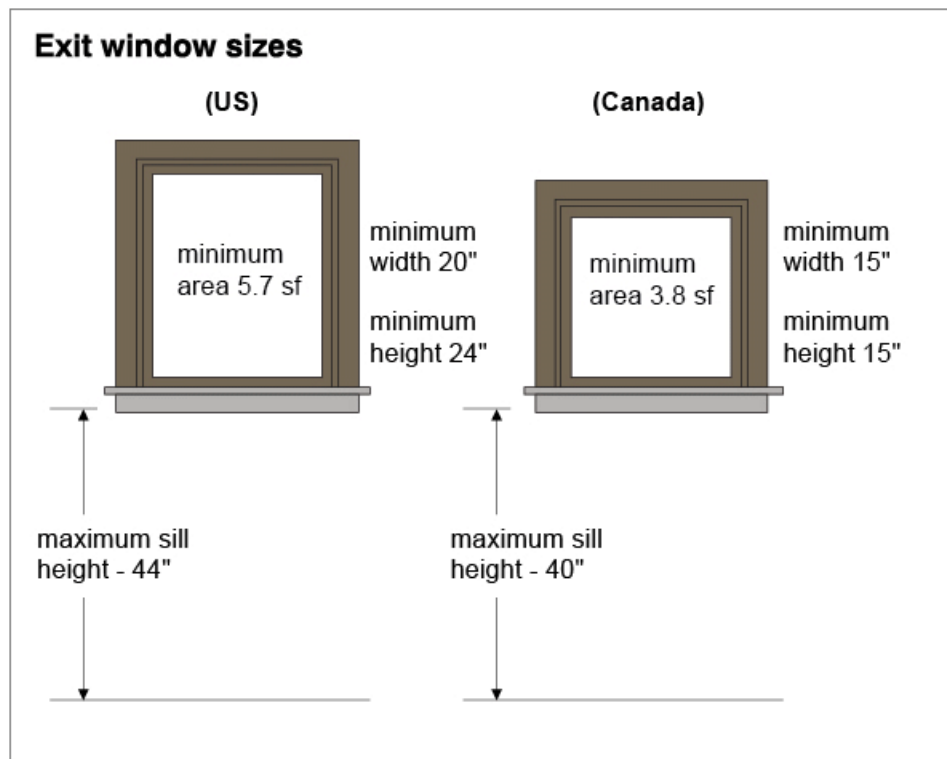
WINDOWS \ Means of egress/escape

Condition: • [Learn more about window egress requirements](#)

Task: Recommend Upgrade to Current Standard

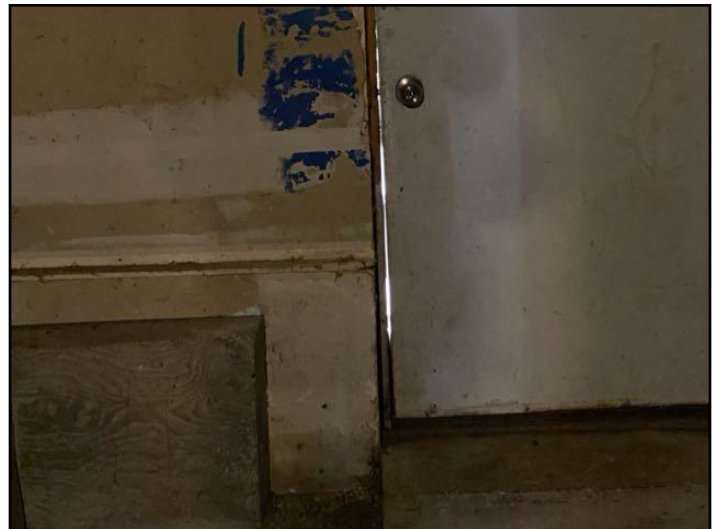
DOORS \ Doors and frames

Condition: • [Weatherstripping missing or ineffective](#)

Task: Service General Repair
