Your Inspection Report

1234 Somewhere St
Saint John, NB E2L 2M9

INSPECTION DATE:
Friday, December 8, 2023

RE: Report No. 3531
1234 Somewhere St
Saint John, NB
E2L 2M9

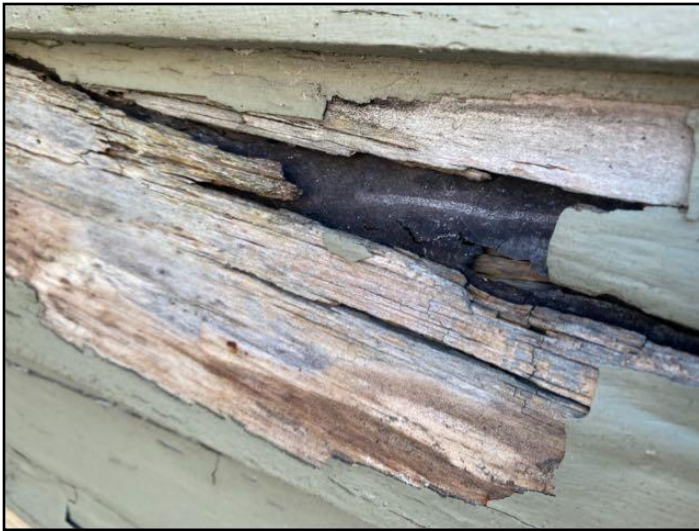
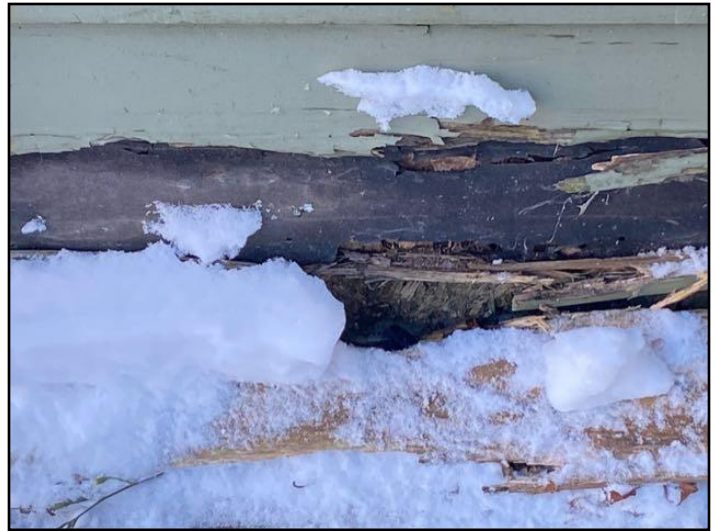
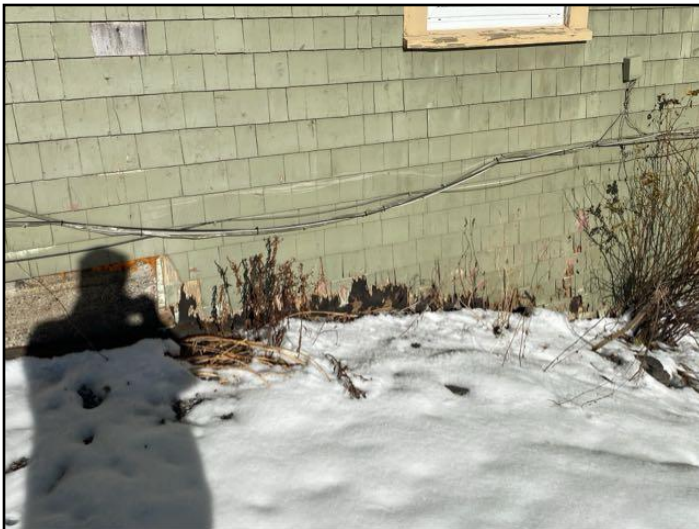
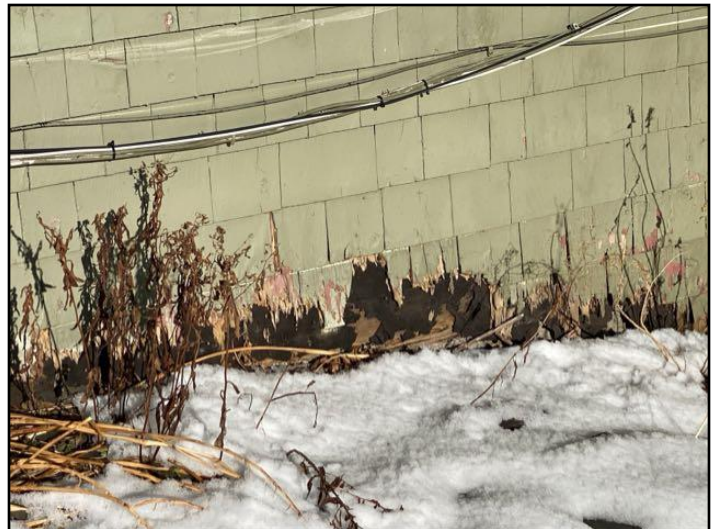
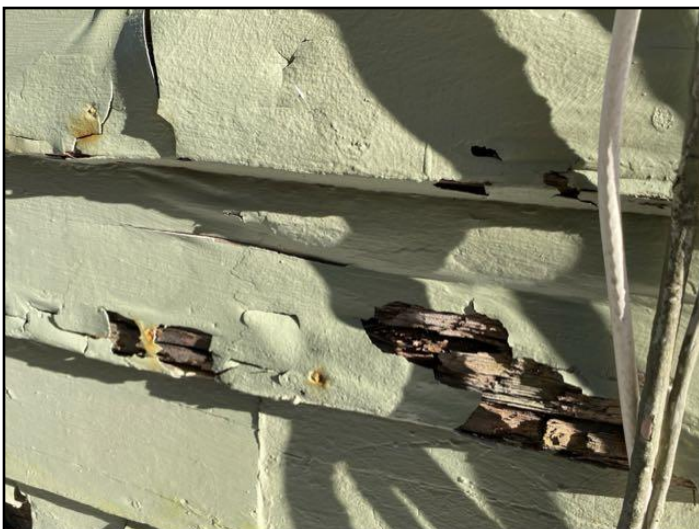
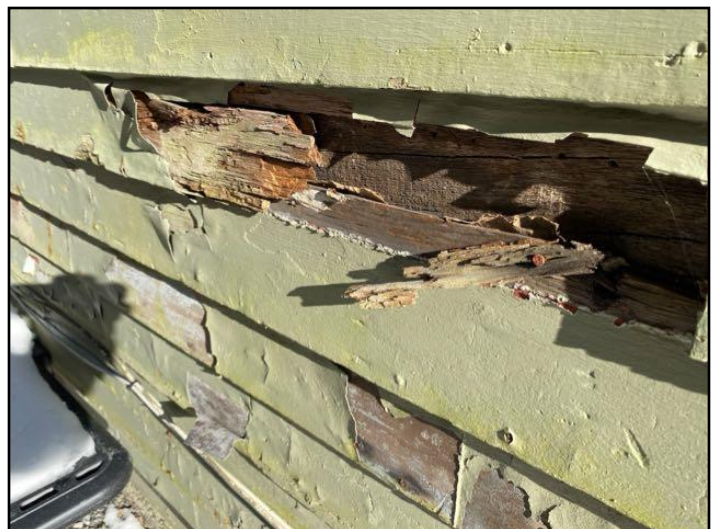
Condition: • [Cracked, split or broken](#)

Rot and damage noted

Implication(s): Chance of water damage to structure, finishes and contents

Task: Service General Repair

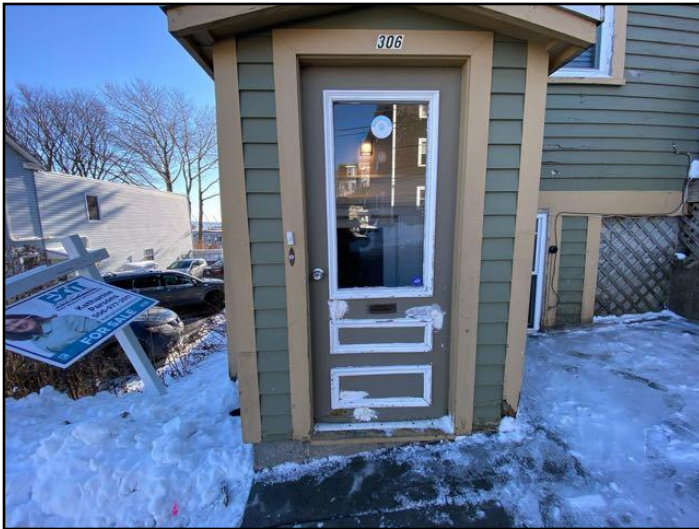
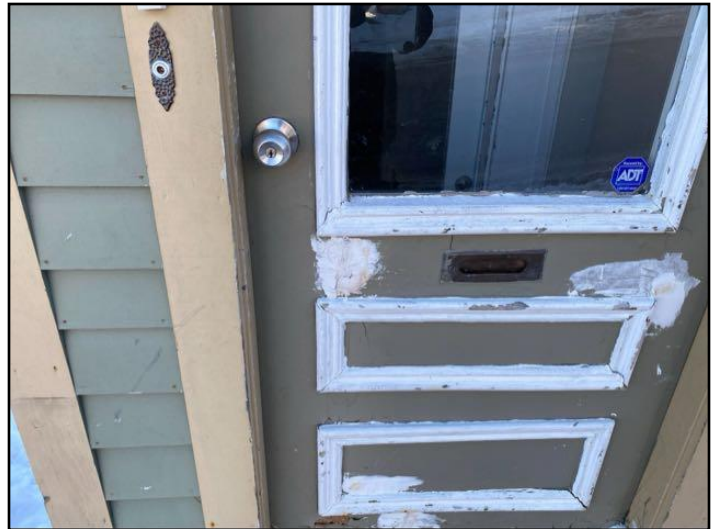
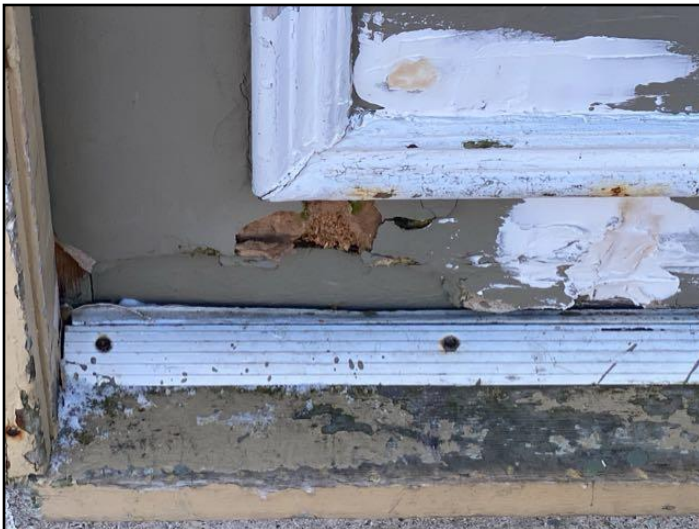
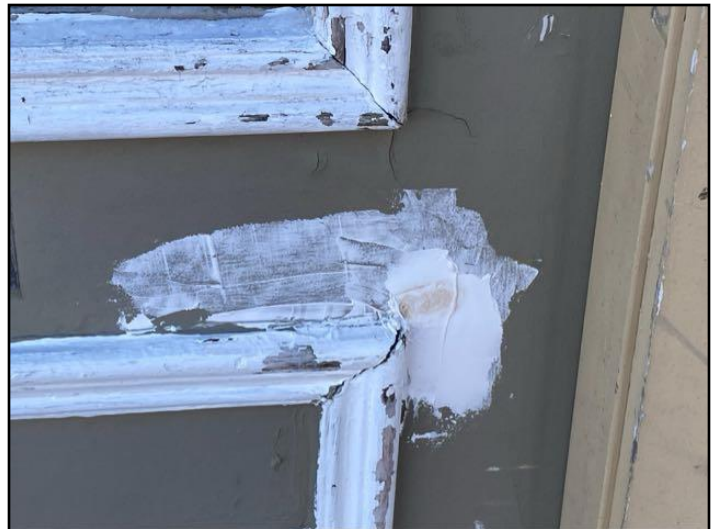
DOORS \ Doors and frames

Condition: • [Damage](#)

Implication(s): Poor security | Chance of damage to finishes and structure

Task: Repair or Replace

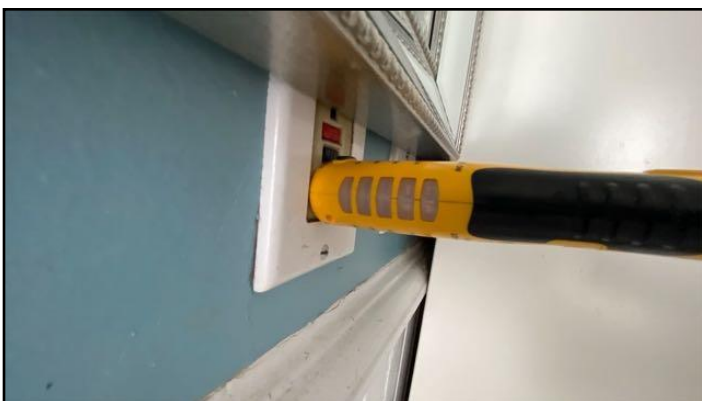
Condition: • The outlet at the bathroom was powered by the light switch. This configuration, although correct, can be an annoyance or inconvenience in today's life style with rechargeable appliance/devices. This configuration would require the light t remain on in order to charge, toothbrushes, razors, phones, etc.

Task: Recommend Upgrade to Current Standard

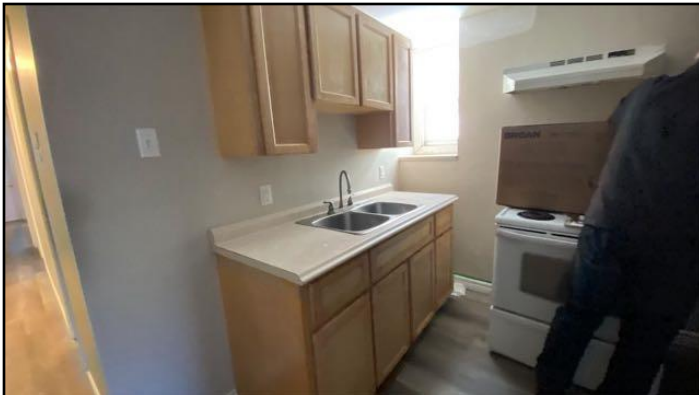
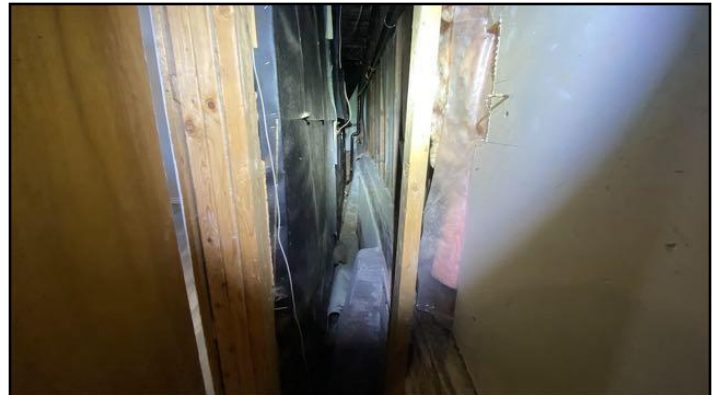
CEILING AND WALLS \ General notes

Condition: • Unfinished

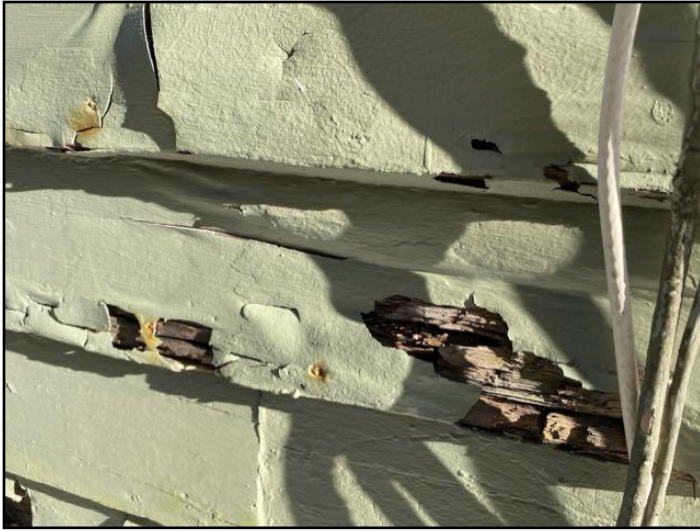
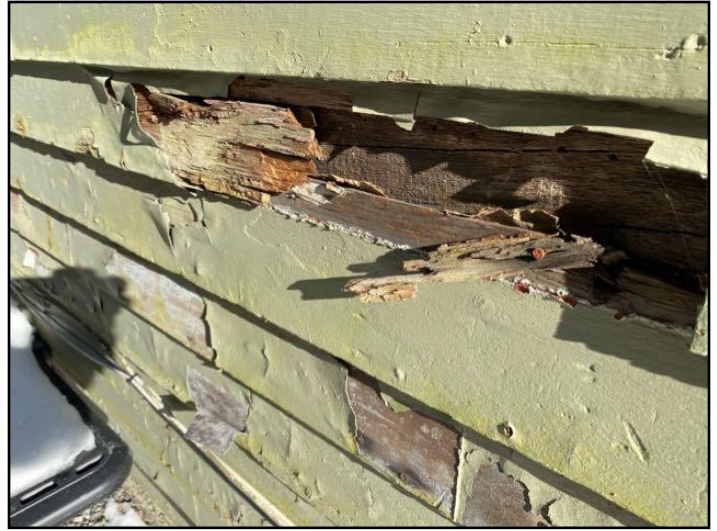
Condition: • [Paint or stain - needed](#)

Implication(s): Shortened life expectancy of material

Task: Service General Repair

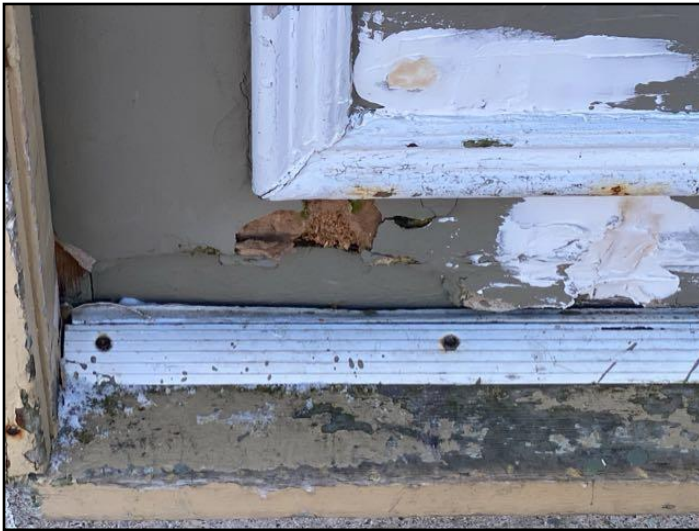
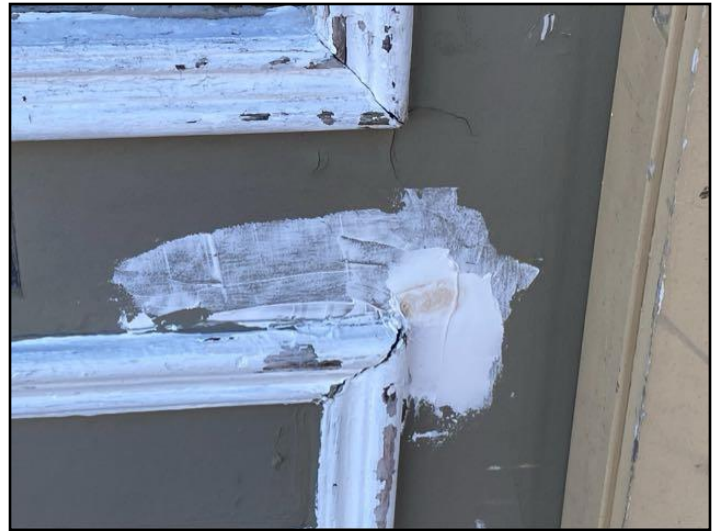
DOORS \ Doors and frames

Condition: • [Damage](#)

Implication(s): Poor security | Chance of damage to finishes and structure

Task: Repair or Replace

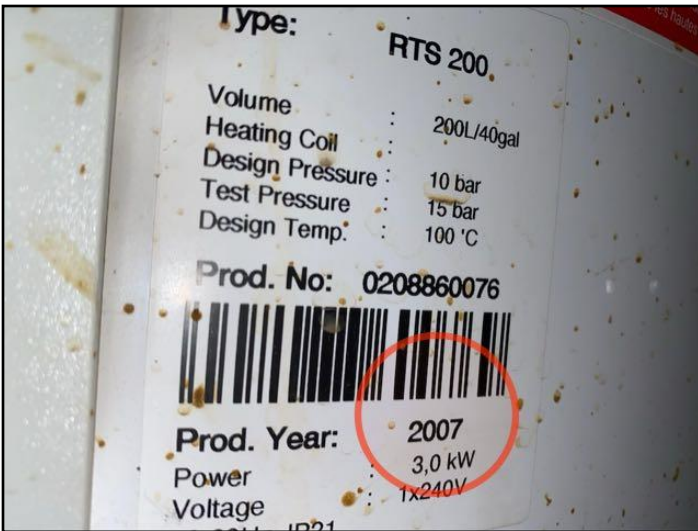
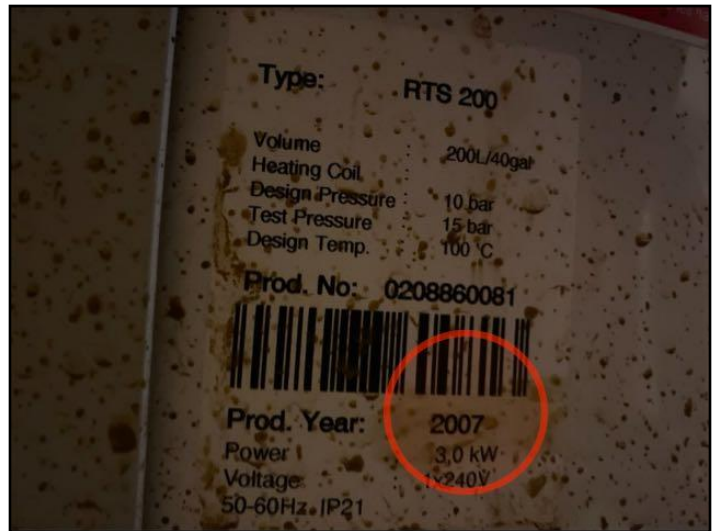
Condition: • The water heater, though functional during the inspection, is past the end of its "approximate" life expectancy (8 to 12 years based on a 2007 study done by the Nation Association of Home Builders) and may need replacement anytime.

Task: Replace

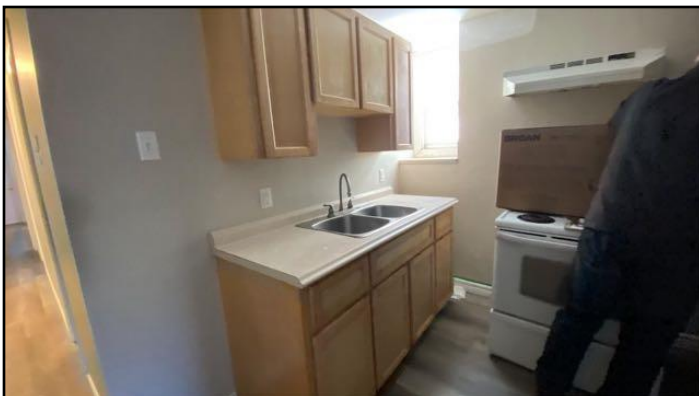
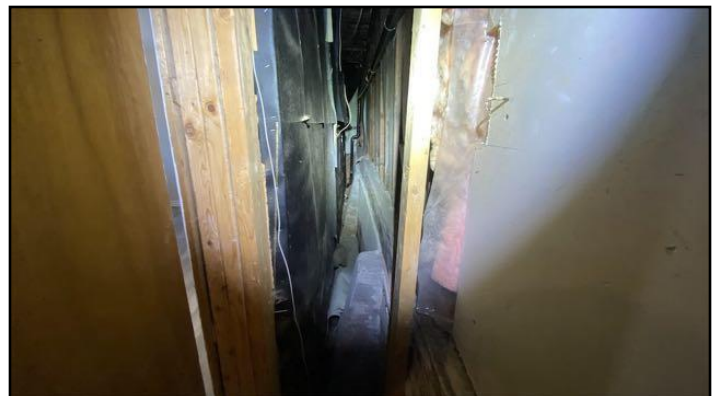
Implication(s): Fire and safety hazard

Task: Further Evaluation by a Specialist

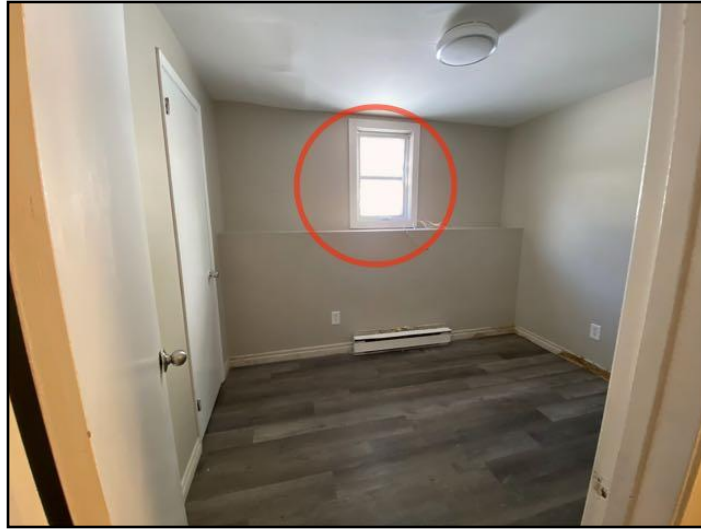
Condition: • [Weatherstripping missing or ineffective](#)

Task: Service General Repair
